Express5800/T120h ご使用時の注意事項

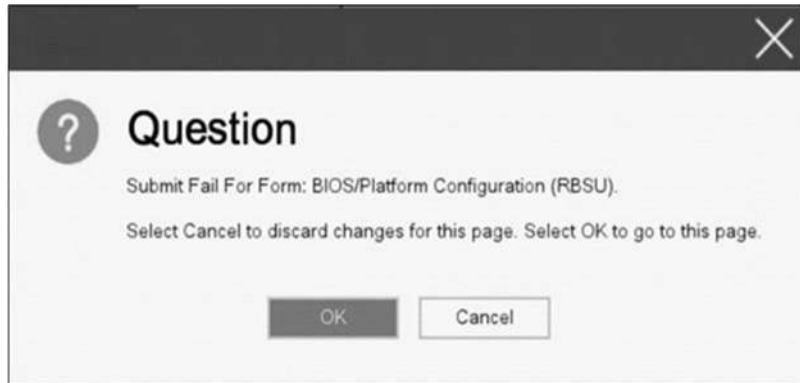
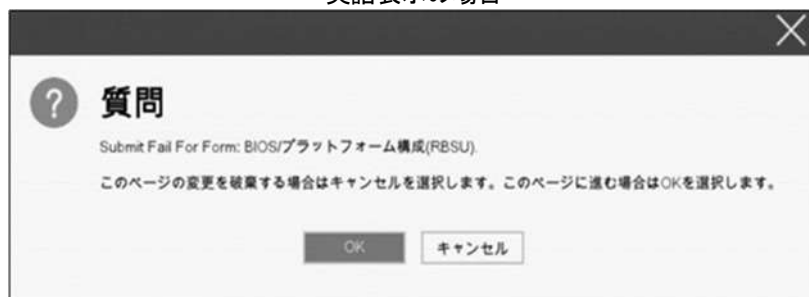
● Submit Fail For FormのQuestion(質問)ポップアップ表示についての注意事項

システムユーティリティにおいて設定の変更中に、次のSubmit Fail For FormのQuestion(質問)ポップアップが表示された場合は、「キャンセル」を選択して変更を破棄してください。

さらに、サーバーの再起動を行ってシステムユーティリティに入りなおしてから設定の変更を再度行ってください。もし「OK」を押してそのまま設定変更を進めると、装置に記録されているSerial Number、Product IDなどの設定情報を消失することがあります。

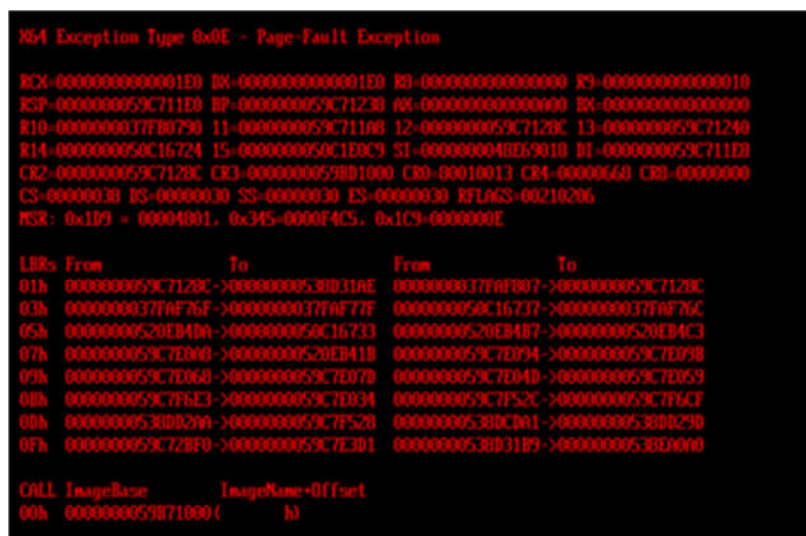
赤文字画面の例

装置の構成変更や設定変更などシステムの状態を変更した場合や、接続デバイスへのアクセスタイミングにより、OS起動前に稀に赤文字画面 (RSOD)が表示され、本製品の操作が出来なくなることがあります。構成変更や設定変更に伴う一過性の事象の場合があり電源OFF/ONによって回復します。

赤文字画面 (RSOD)が表示された場合、装置の電源OFF/ONをお願いします。

問題が解決しないときは、ファーストコンタクトセンターにお問い合わせください。

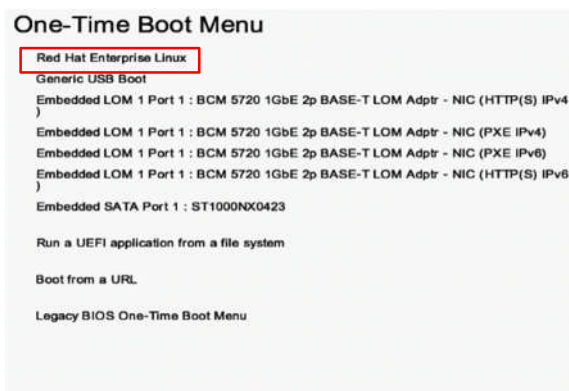
ワンタイムブートメニュー画面

OSがインストールされたHDDやSSDなどのブートデバイスを選択した場合、Red Screen of Death (RSoD)が発生することがあります。

ワンタイムブートメニューから起動する場合、OSブートマネージャー(例: Red Hat Enterprise Linux)を選択してください。

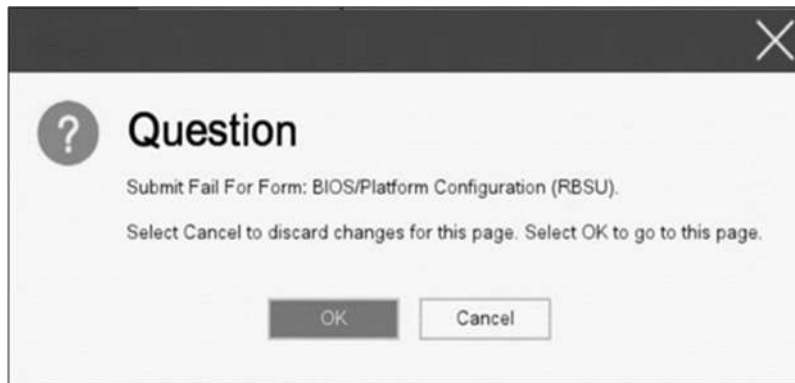
● Caution for the “Submit Fail For Form” Question pop-up

If you encounter the “Submit Fail For Form” Question pop-up while changing the configuration in the System Utilities, **discard the changes by pressing Cancel**. To apply the desired changes after that, reboot the server and re-enter the System Utilities. Selecting OK to continue the changes may cause some server settings such as Serial Number and Product ID to be lost.
