# Express5800/R120h-1E, R120h-2E ご使用時の注意事項

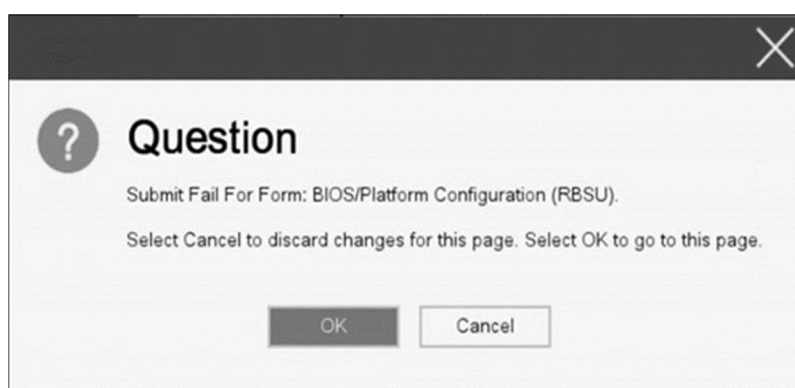
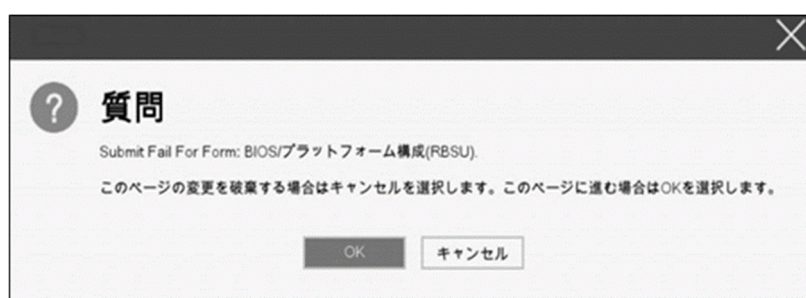
### ● Submit Fail For FormのQuestion(質問)ポップアップ表示についての注意事項

システムユーティリティにおいて設定の変更中に、次のSubmit Fail For FormのQuestion(質問)ポップアップが表示された場合は、「キャンセル」を選択して変更を破棄してください。

さらに、サーバーの再起動を行ってシステムユーティリティに入りなおしてから設定の変更を再度行ってください。もし「OK」を押してそのまま設定変更を進めると、装置に記録されているSerial Number、Product IDなどの設定情報を消失することがあります。

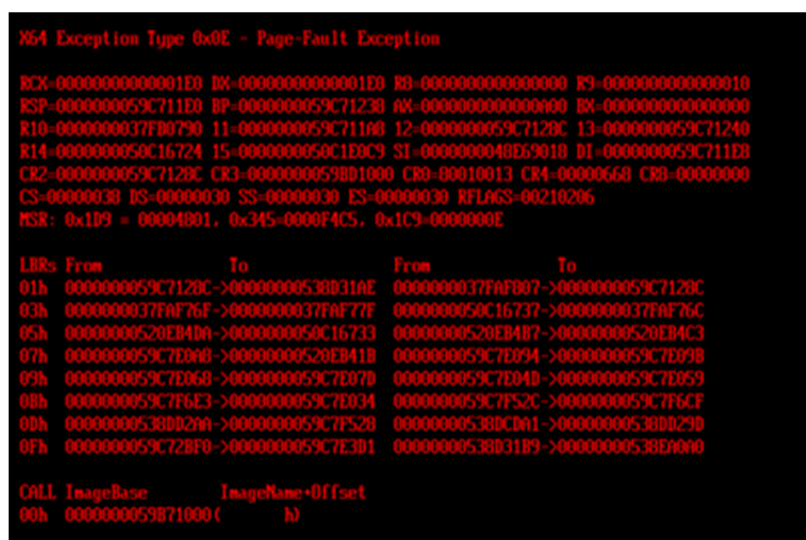
赤文字画面の例

装置の構成変更や設定変更などシステムの状態を変更した場合や、接続デバイスへのアクセスタイミングにより、OS 起動前に稀に赤文字画面 (RSOD) が表示され、本製品の操作が出来なくなることがあります。構成変更や設定変更に伴う一過性の事象の場合があり電源 OFF/ON によって回復します。

赤文字画面 (RSOD) が表示された場合、装置の電源 OFF/ON をお願いします。

問題が解決しないときは、ファーストコンタクトセンターにお問い合わせください。

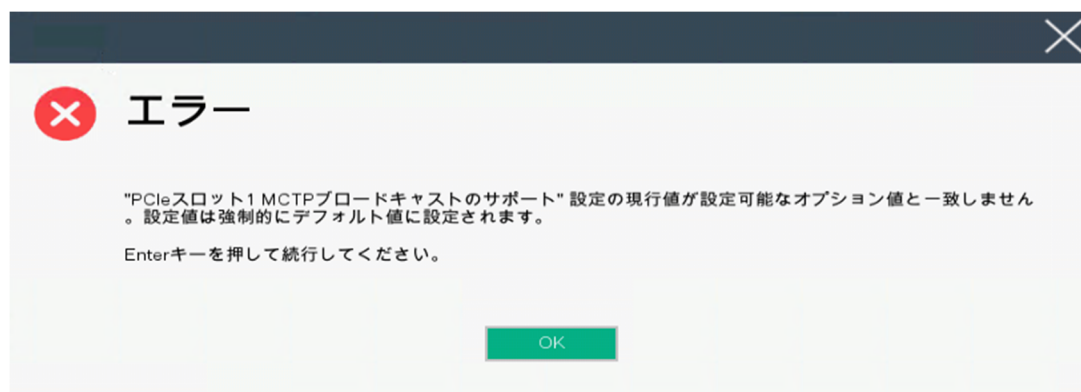
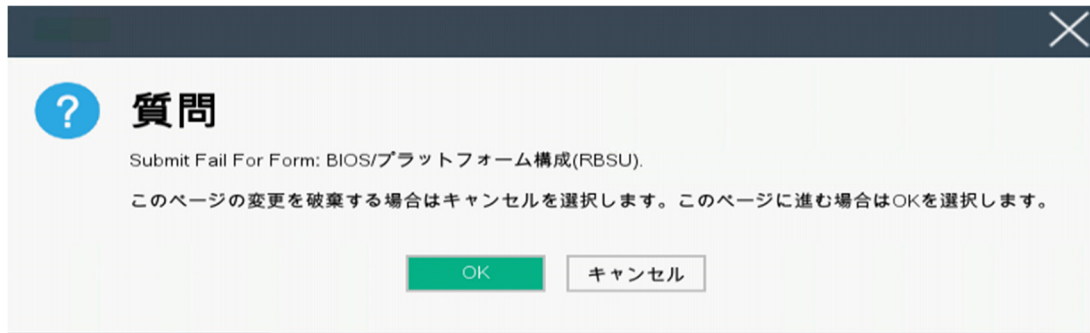
システム ROM バージョンが v2.10 (05/21/2019) 以降の装置において、初めて PCIe MCTP Options メニュー(\*)を選択した場合、装置のデフォルト設定を強制的に設定する旨のポップアップ(\*)が、設定可能な PCIe Slot 数分表示されます。

なお、下記システム ROM バージョンの場合、設定保存時にポップアップ(\*)が表示され設定は保存されません。保存されないことにより、本メニューを表示させるたびに PCIe Slot 数分のポップアップ(\*)が表示されることになります。この場合、MCTP Broadcast は常に有効で動作します。

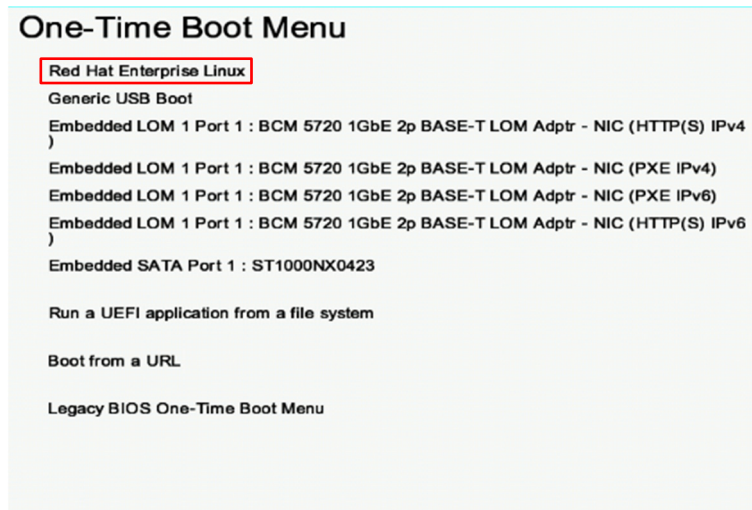
ワンタイムブートメニュー画面

OSがインストールされたHDDやSSDなどのブートデバイスを選択した場合、Red Screen of Death (RSoD) が発生することがあります。

ワンタイムブートメニューから起動する場合、OSブートマネージャー (例: Red Hat Enterprise Linux) を選択してください。

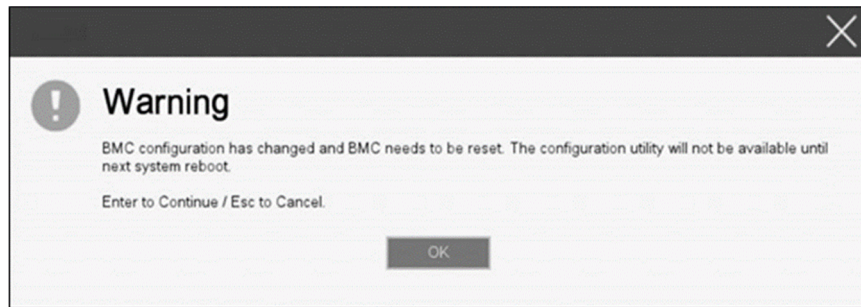
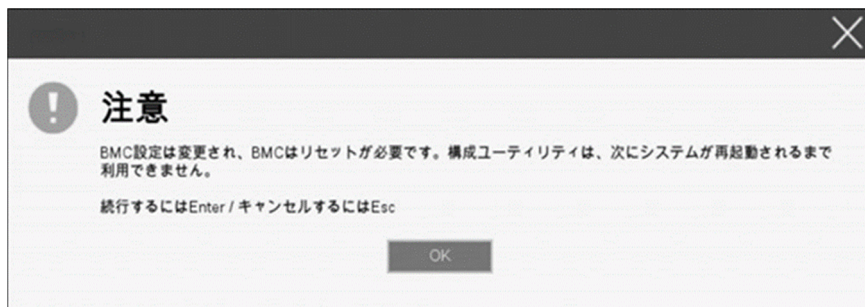
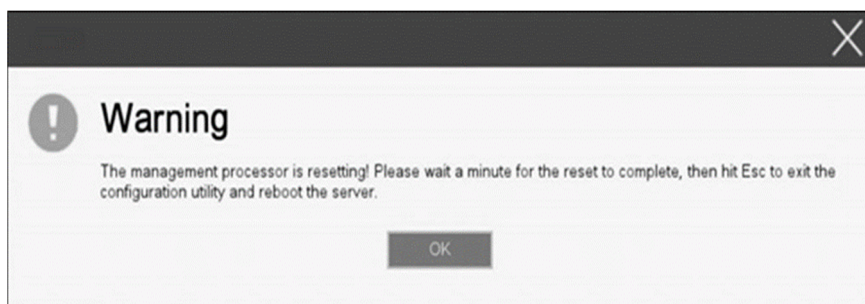
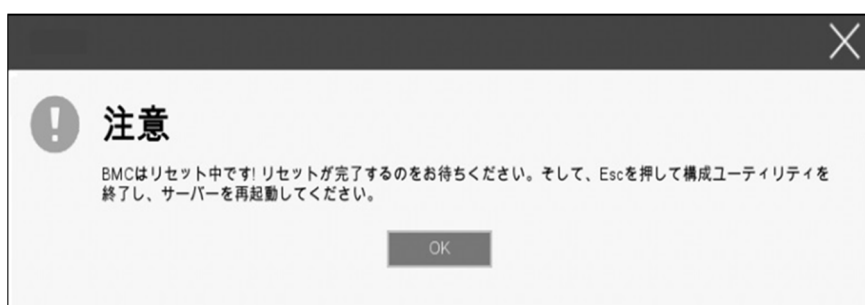
注意事項に従った操作を実施されない場合、「Memory Initialization Start」のメッセージでPOST停止、あるいは、装置に記録されているSerial Number、Product IDの消失が発生する場合があります。

- (1) システムユーティリティの「BMC Configuration Utility」において設定の変更を行うと、iLOの再起動を行うために、次のWarning (注意) ポップアップが表示されることがあります。

- (2) 「OK」を押して進めます。

- (3) 次のWarning (注意) ポップアップが表示されます。

このWarning (注意) ポップアップが表示されている状態にて、**必ず1分以上お待ちください。**その間、何も操作しないでください。

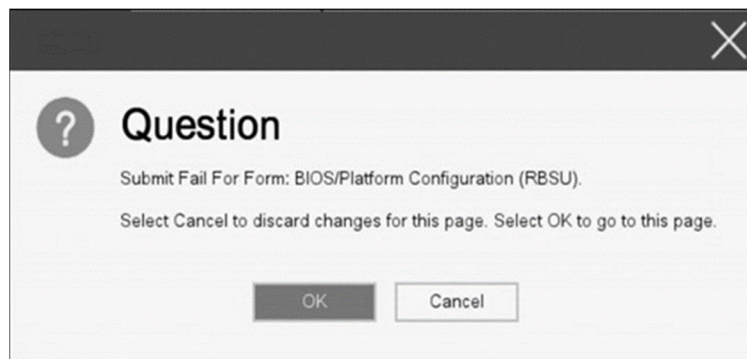
### • Caution for the “Submit Fail For Form” Question pop-up

If you encounter the “Submit Fail For Form” Question pop-up while changing the configuration in the System Utilities, **discard the changes by pressing Cancel**. To apply the desired changes after that, reboot the server and re-enter the System Utilities. Selecting OK to continue the changes may cause some server settings such as Serial Number and Product ID to be lost.

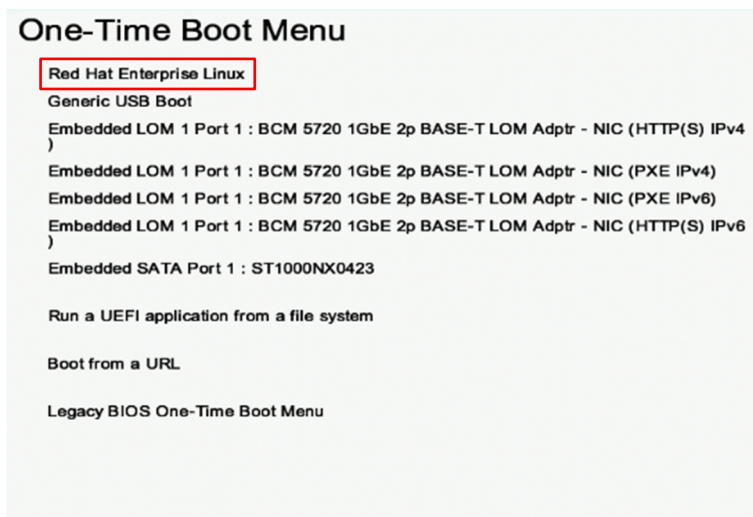
One-Time Boot Screen

Selecting an OS boot device such as HDD/SSD on the "One-Time Boot Menu" may cause RSoD (Red Screen of Death).

Select "OS Boot Manager" when booting OS from "One-Time Boot Menu".
