About Updating RAID Controller Firmware

Please review the following important points regarding the RAID controller firmware update using Starter Pack S8.10-010.12.

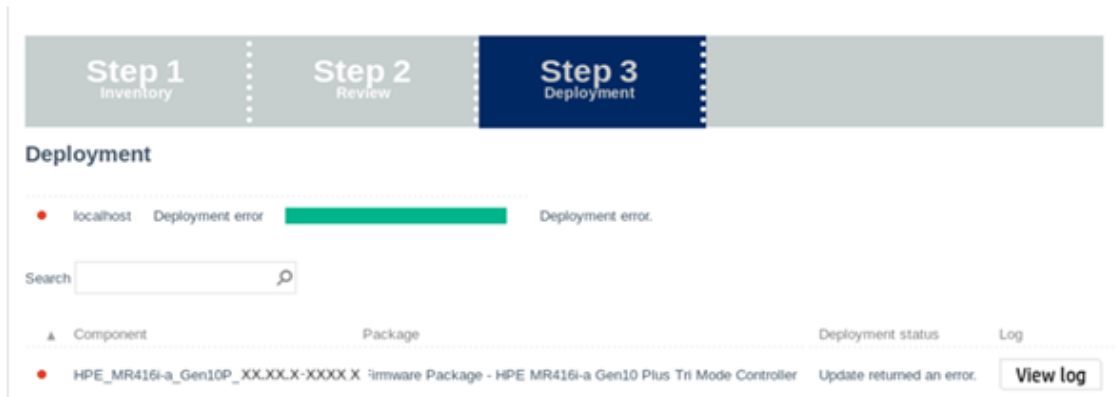
4. When using N8103-240

After applying the Starter Pack (ver. S8.10-010.12), an error screen may appear. However, if the firmware version is updated to "52.32.3-6333" after rebooting, there is no issue. If the firmware version is not updated to "52.32.3-6333", reapply the Starter Pack (ver. S8.10-010.12).
