Express5800/T120h ご使用時の注意事項

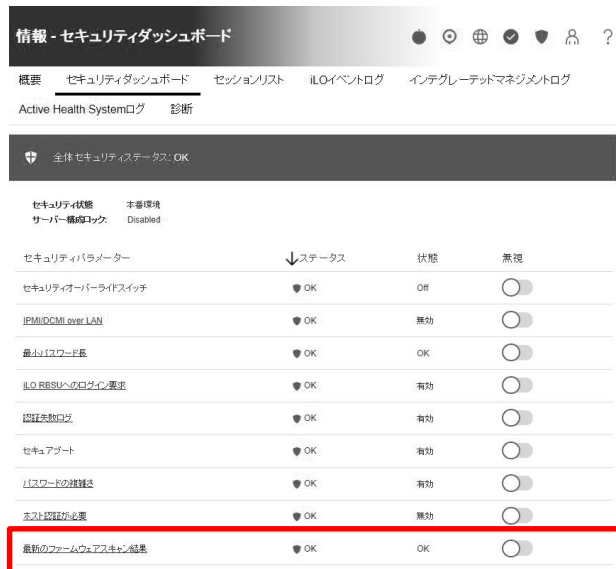
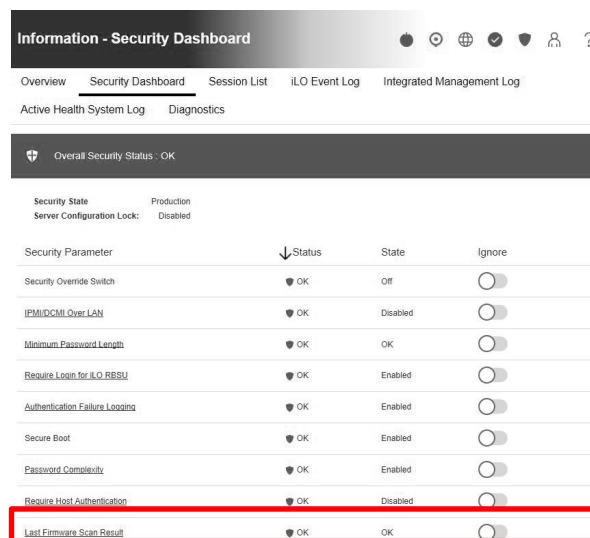
iLO 5ファームウェアバージョン1.43以上、2.10未満をご使用の場合、[Information] - [Security Dashboard]に [Last Firmware Scan Result]が表示されますが、本ハイパーリンクをクリックしないでください。

誤ってクリックした場合、Webサイト内のメニュー間移動が出来なくなります。その場合、ブラウザのリロードボタンをクリックするか、もしくはいったんiLO Webインターフェースのログアウトを実行して再度ログインしてください。
