About Updating RAID Controller Firmware

Please review the following important points regarding the RAID controller firmware update using Starter Pack S8.10-010.11.

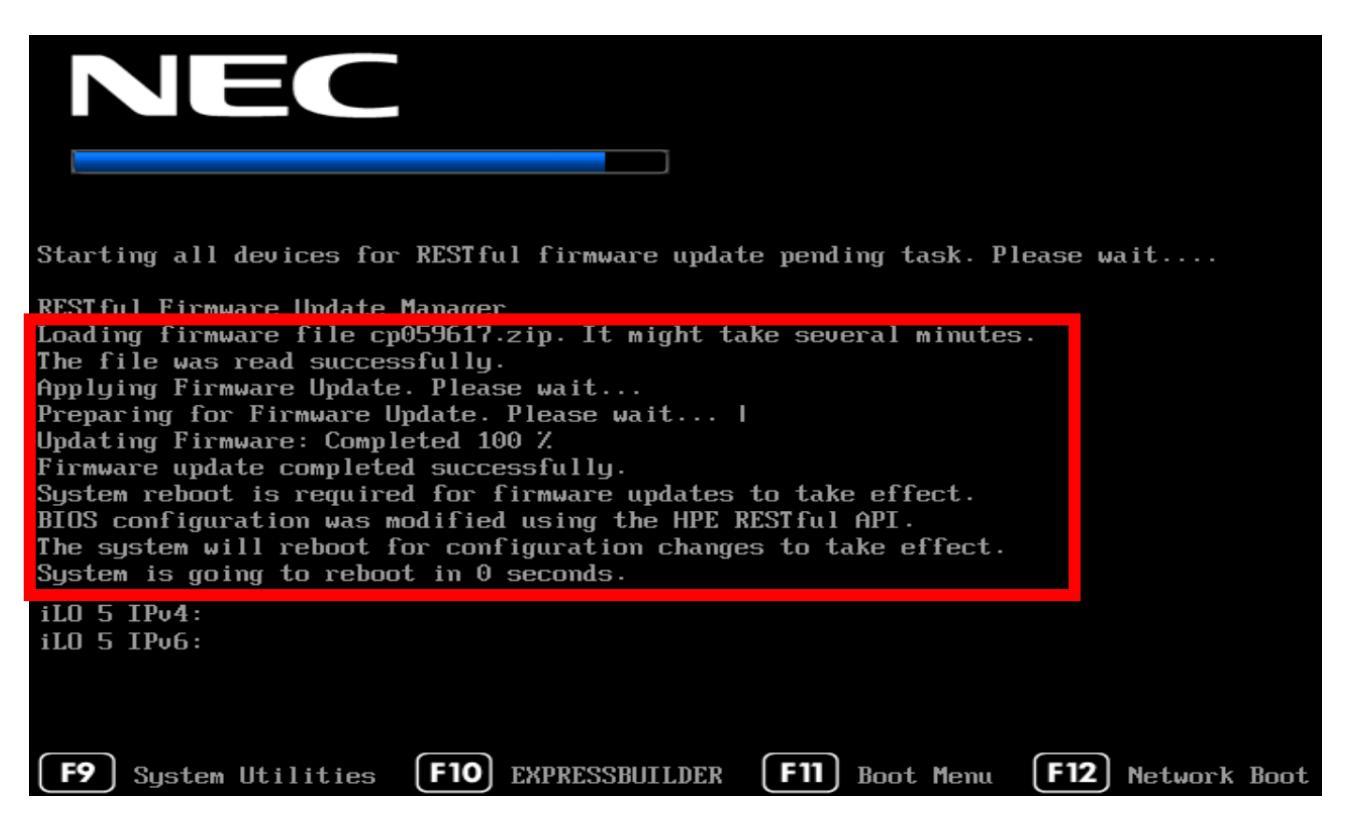
1. Please follow the instructions on the Starter Pack public site to apply this Starter Pack (ver. S8.10-010.11) and reboot (1st time). If the SPS firmware is updated, it will be updated during POST, and the system will automatically reboot (2nd time).

2. Please start the OS. If the OS is not installed due to re-setup, press F9 during POST to transition to the System Utilities.

At this point, it has been updated to Firmware 5.61/Firmware 1.0.14.1063. A background update to Firmware 7.11/Firmware 1.2.14.1018 will start 2 to 3 minutes after booting. You can check the update progress after logging into the iLO Web Interface. In environments where the iLO Web Interface cannot be used, perform a reboot approximately one hour later (3rd time) and proceed to Step 4.
